Manhole Inspection Summary

Manhole # S25EE1017MH

Location Address: **1313 40TH ST**

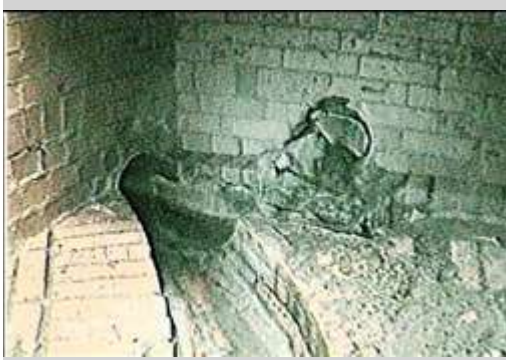
Pipes under the overhang

O12 and the I3. Barrel deterioration and infiltration.

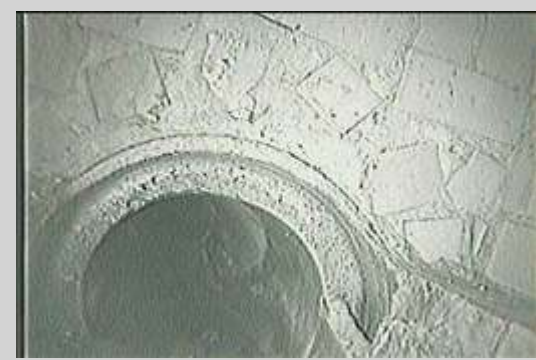
8 in. Circular Gravity Sewer Pipe Out @ 12 O'Clock

Infiltration: **Evidence** Pipe Seal Cond: **Unknown**

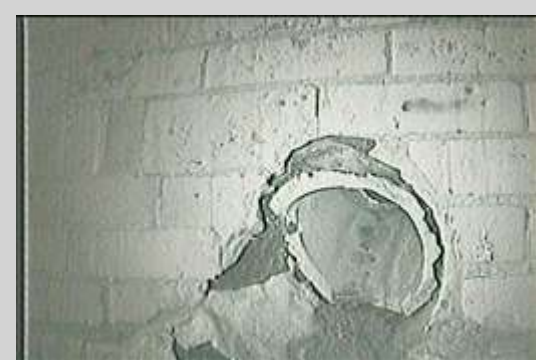
6 in. Circular Gravity Sewer Pipe In @ 3 O'Clock

Infiltration: **Evidence** Pipe Seal Cond: **Unknown**

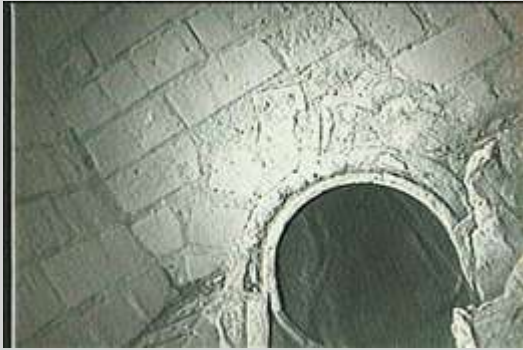
Pipe In @ 5 O'Clock

Infiltration: **Evidence** Pipe Seal Cond: **Unknown**

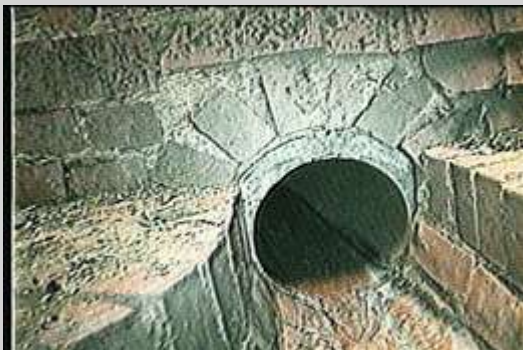
Pipe In @ 7 O'Clock

Comments **The I7 pipe picture shows Channel deterioration.**
